National Highway
Traffic Safety
Administration

Case Vehicle (A): 1999 Dodge
 Type: Ram 1500 Quad Cab, 4x2 pickup
 Driver: 33-year-old male
 CDC: 71-FLEW-4

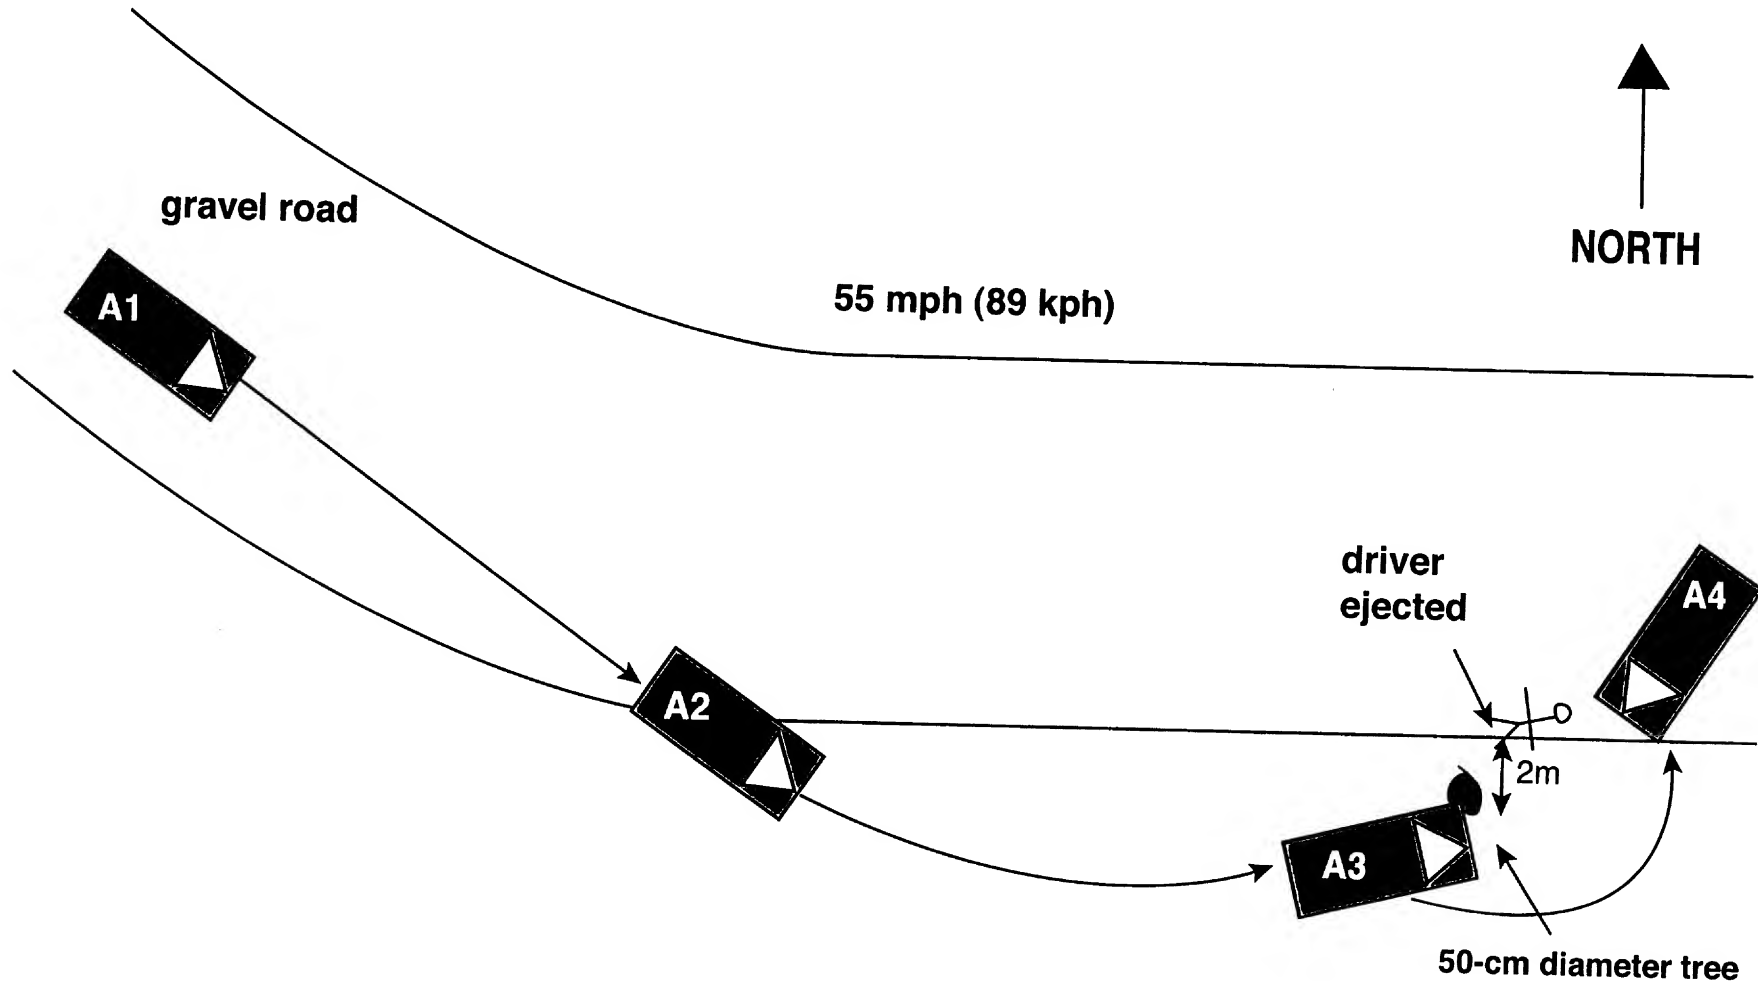
ACCIDENT SCHEMATIC

ACCIDENT DESCRIPTION: CASE VEHICLE (A) WAS TRAVELING
EAST AT AN UNKNOWN SPEED ON A GRAVEL
ROAD. THE DRIVER LOST CONTROL OF THE VEHICLE,
EXITED THE SOUTH EDGE OF THE ROAD, AND STRUCK A 50-CM DIAMETER
TREE LOCATED 2-M SOUTH OF THE ROAD EDGE. AFTER THE IMPACT, CASE VEHICLE
(A) ROTATED COUNTERCLOCKWISE AND THE DRIVER WAS COMPLETELY EJECTED FROM THE
VEHICLE.

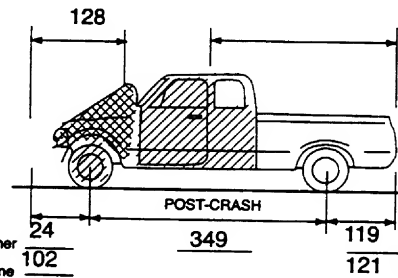
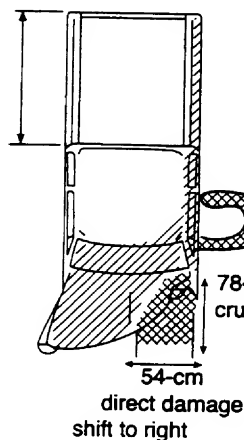
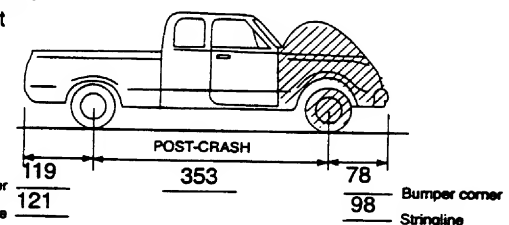
VEHICLE DAMAGE

stringline was set up at
451 (wb and foh) should
have been 449 subtract
2-cm from all c's

window frame
bowed out

Bumper corner
Stringline

Specific Impact Number	Plane of Impact C-Measur.	Direct Damage		Field L	C ₁	C ₂	C ₃	C ₄	C ₅	C ₆	±D
		Length (DDL)	Max Crush								
1	1	54	98	111	98	73	53	38	27	23	-29
stringline adjustment			-2		-2	-2	-2	-2	-2	-2	
FREESPACE			18		18	0	0	0	0	18	
TOTAL			78		78	71	51	36	25	3	
1	1	054	078	111	078	071	051	036	025	003	-029
13	14	15 16 17	18 19 20	21 22 23	24 25 26	27 28 29	30 31 32	33 34 35	36 37 38	39 40 41	42 43 44 45
2

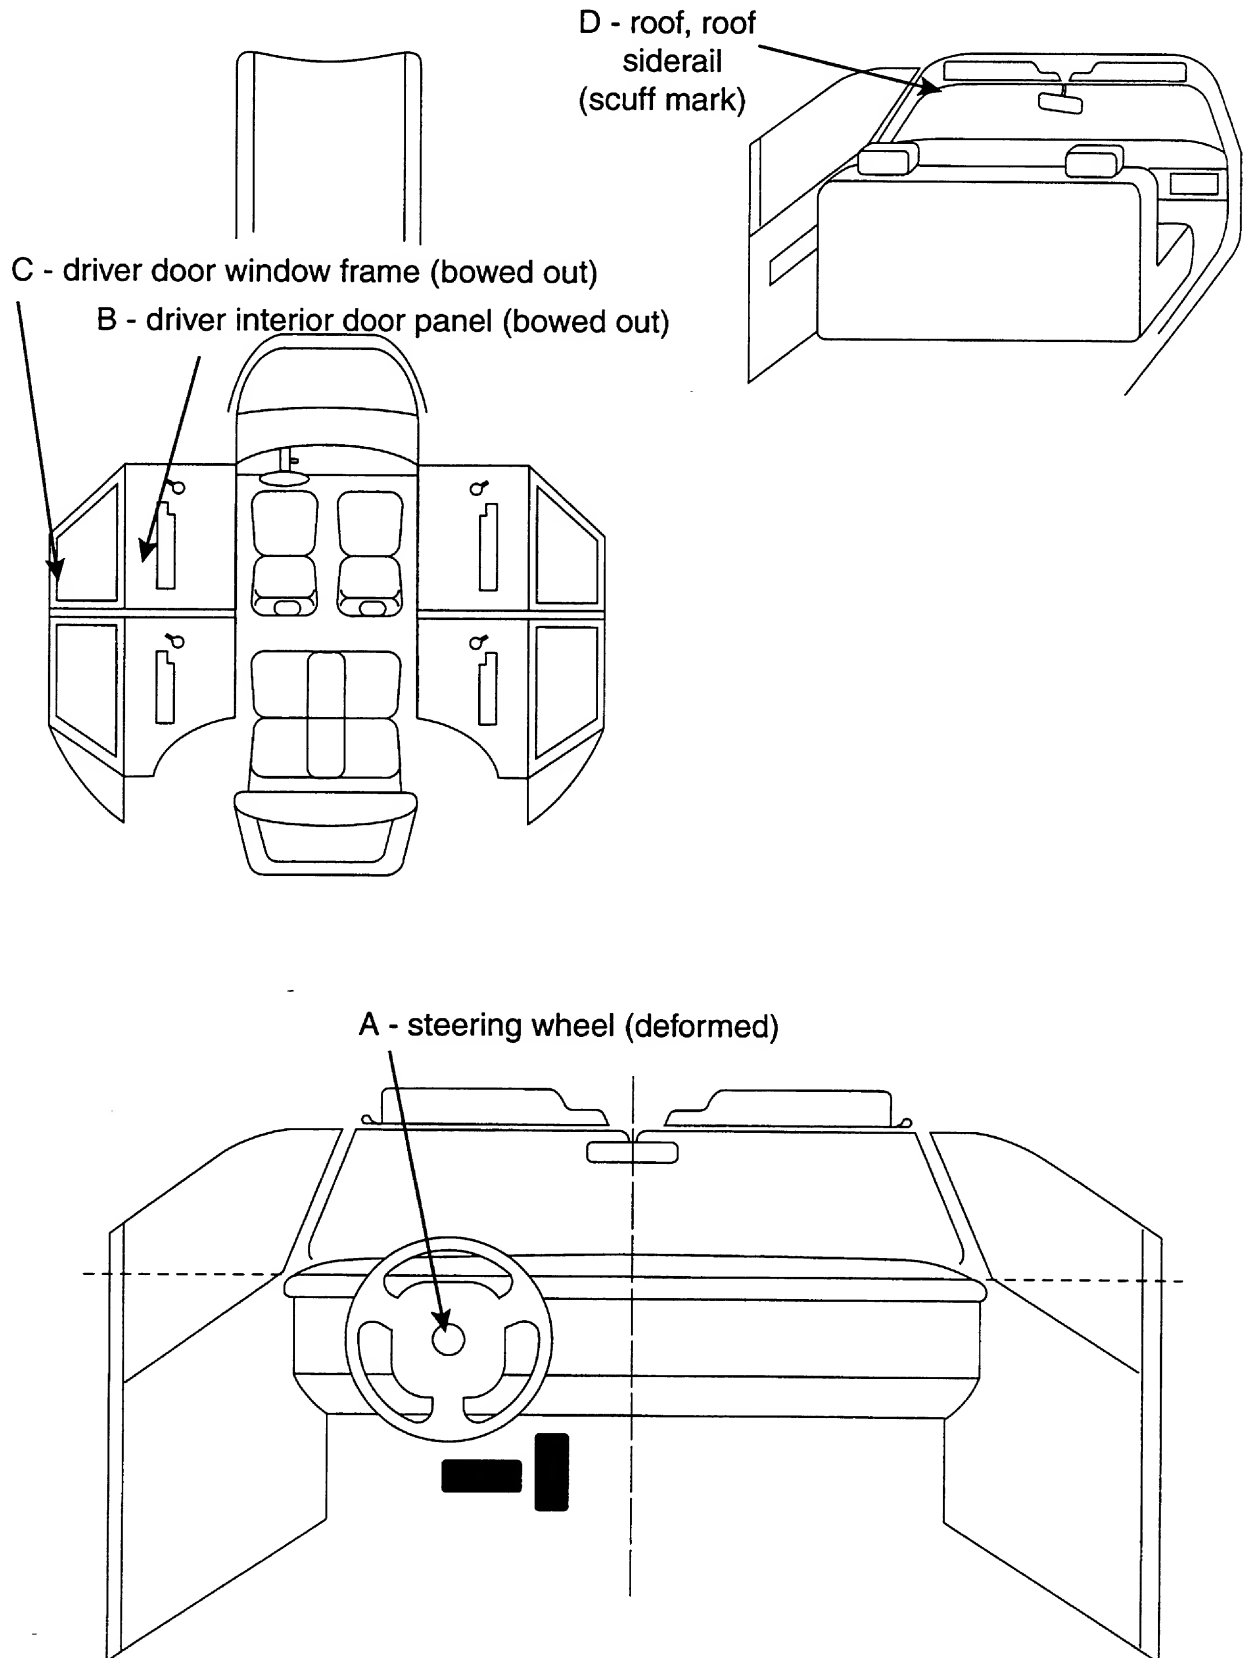
VEHICLE OCCUPANT CONTACT DIAGRAM

Contact	Interior Component Contacted	Occupant No. if Known	Body Region if Known	Supporting Physical Evidence	Confidence Level of Contact Point
A	steering wheel	1	chest	deformed	2
B	driver door panel	1	body	bowed out	1
C	driver door window frame	1	body	bowed out	1
D	roof, roof siderail	1	head	scuffmark	2
E					
F

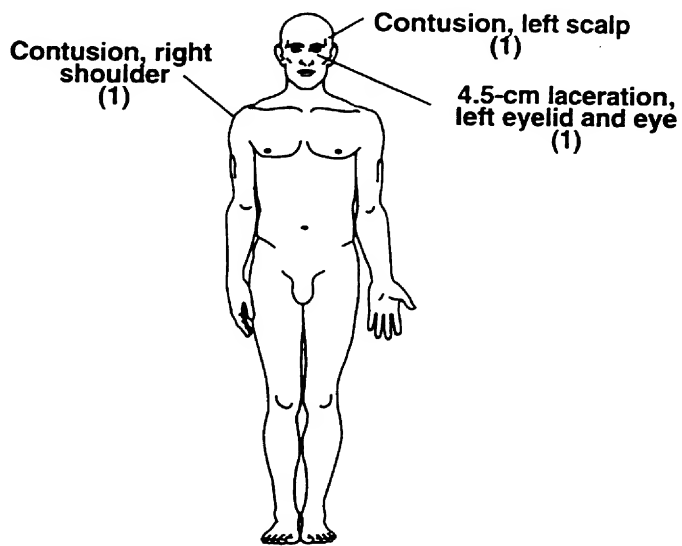
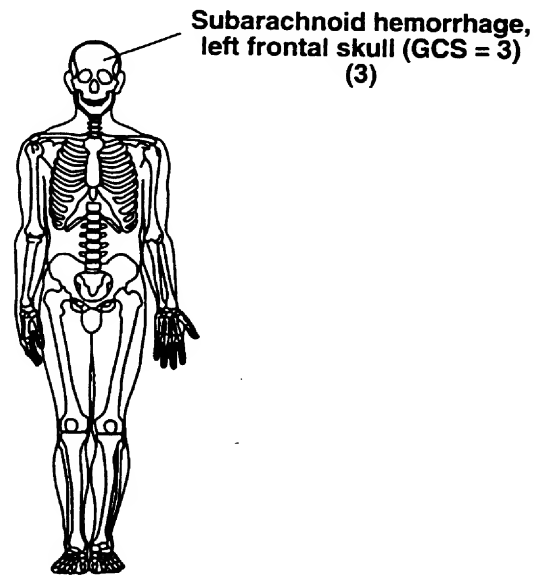
INDICATE LOCATION OF INJURIES.

Injury Description	A.I.S.	Injury Source		
		Definite	Probable	Possible
Subarachnoid hemorrhage, left frontal skull (GCS = 3)	3			Ground (ejection), door/window frame, roof siderail
Contusion, left scalp	1			Ground (ejection), door/window frame, roof siderail
4.5-cm laceration, left eyelid and eye	1			Ground (ejection), door/window frame, roof siderail
Contusion, right shoulder	1			Ground (ejection), door/window frame, roof siderail
<u>Maximum A.I.S. Level</u>	<u>3</u>			
<u>Injury Severity Score</u>	<u>10</u>			
Blood alcohol content is .22 percent				
Driver was completely ejected from vehicle

blood alcohol = .22 percent

The driver sustained a subarachnoid hemorrhage to the left frontal portion of his skull and had a Glasgow Coma Score of 3 upon arrival at the hospital. He also sustained a contusion to his left scalp and a 4.5-cm laceration to his left eyelid and eye. He sustained a contusion to his right shoulder. (Slides 60, 61, and 62) All of these injuries are due to contact with the driver door interior or door window frame during ejection, from contact with the ground, or possibly from contact with the roof and roof siderail.
